AIR ACCIDENT INVESTIGATION BOARD, NORWAY (AAIB/N)

REP.: 47/2001

**REPORT ON THE AIR ACCIDENT 8 SEPTEMBER 1997 IN THE
NORWEGIAN SEA APPROX. 100 NM WEST NORTH WEST OF
BRØNNØYSUND, INVOLVING EUROCOPTER AS 332L1 SUPER PUMA,
LN-OPG, OPERATED BY HELIKOPTER SERVICE AS**

ISSUED NOVEMBER 2001

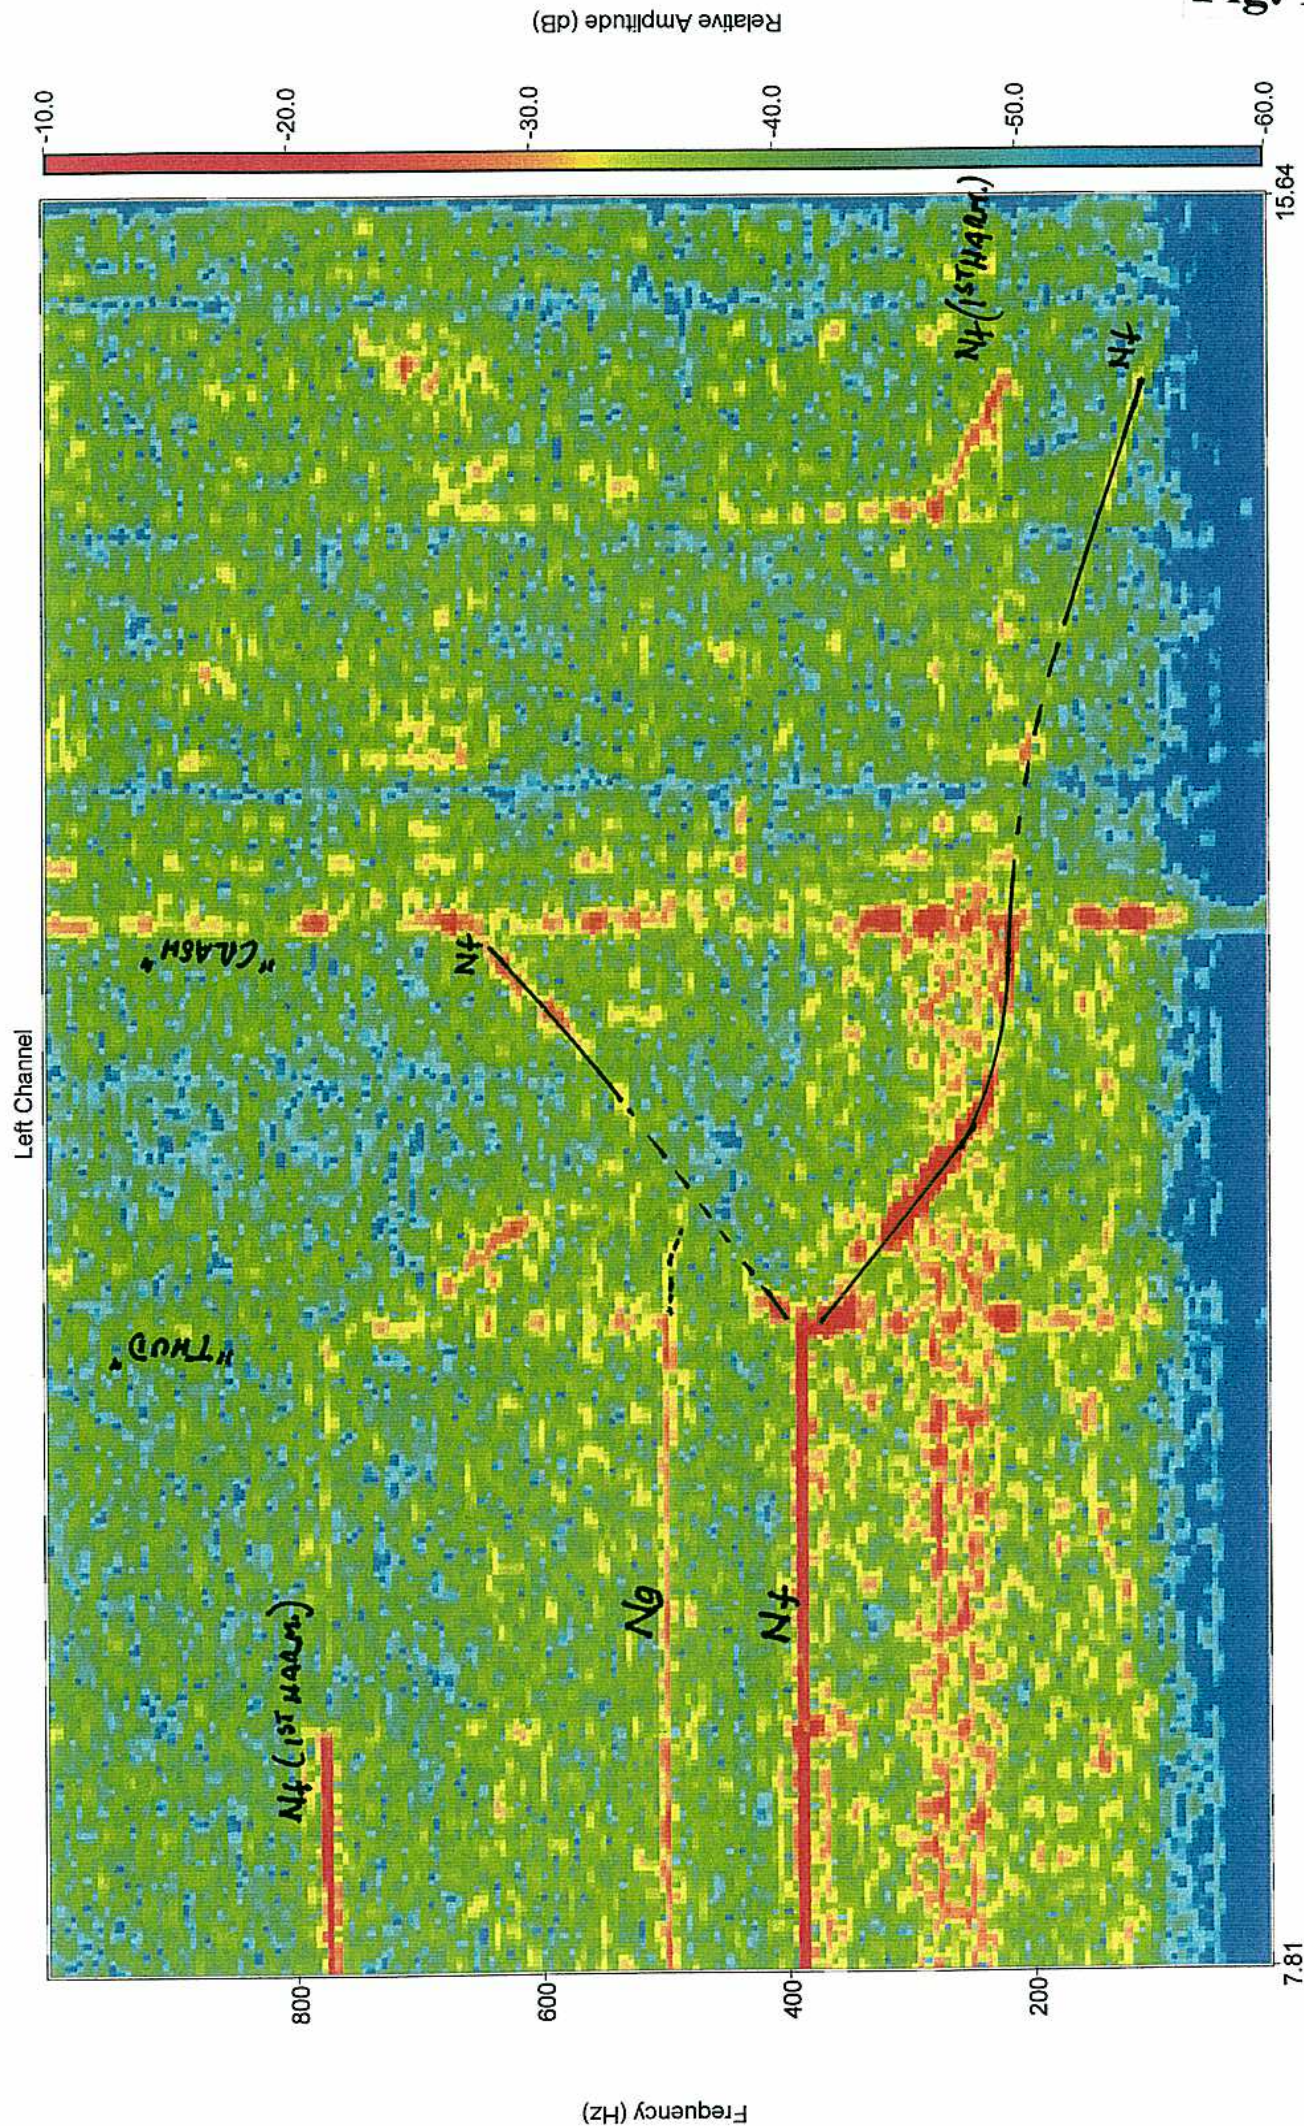
Fig. 12

event may have led to the harmonic overtones from the Bendix shaft disappearing around 1.6 secs. prior to T (see fig. 12). The loading from the lock washer led to the shaft losing balance completely and to the shaft wall being torn after a short time due to static overload. This was recorded by the CVR as a thud in the helicopter (T). Because of the torque transmitted by the shaft, it tore in a spiral pattern. At the same time, the shaft split close to the MGB and the spiral end of the Bendix shaft continued to rotate, powered by the R/H engine. The AAIB/N believes that the spiral spread and increased in diameter so that rotation marks were left inside the liaison tube and on the front of the bellows in the MGB end of the Bendix shaft. As a result of this, fragments of the Bendix shaft were torn off and the lock washer and circlip sustained damage. The section of the Bendix shaft (the spiral) that continued to be powered by the power turbine had completely lost equilibrium and transmitted a torque, caused by the "braking effect" due to contact with the inner wall of the liaison tube and the MGB end of the Bendix shaft. These loadings led to the shaft also being split at the bellows at the "engine end". In the first second after the first shaft fracture, the AAIB/N believes it can be established that the engine's EECU recorded an increase in the Nf 2. A reaction to this would be for the EECU to reduce the supply of fuel to the engine with a consequent reduction of Ng 2. This can be confirmed by the fact that the FDR recorded a drop in Ng 2 for a short period. The AAIB/N believes that the R/H EECU then lost Nf information. The system for speed control and overspeed protection was then disabled. The built-in logic then caused the EECU to increase its fuel supply to the engine to achieve 104% Ng. The power turbine, which had no loading at all, then increased its RPM to approx. 175% Nf. At this speed, it was torn to pieces by centrifugal forces and fragments were ejected with great force from the rotation plane of the power turbine.

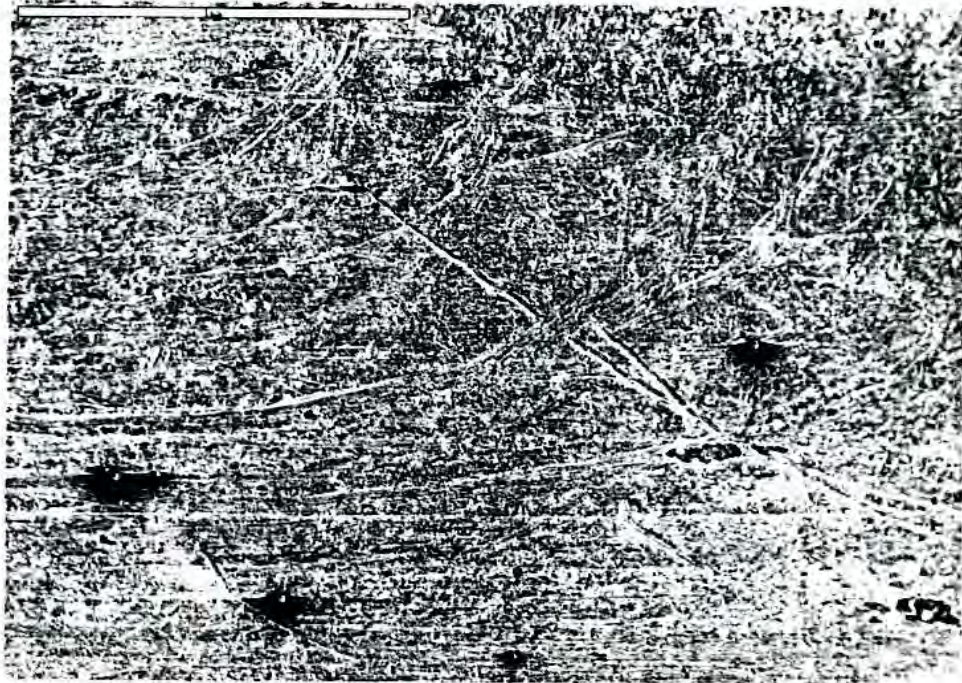
SEM-view of the end section of some of the mechanical scratches/scores, seen on the hardmetal coated inactive flank of the exterior spline, tooth No. 6. Magnification X 50.

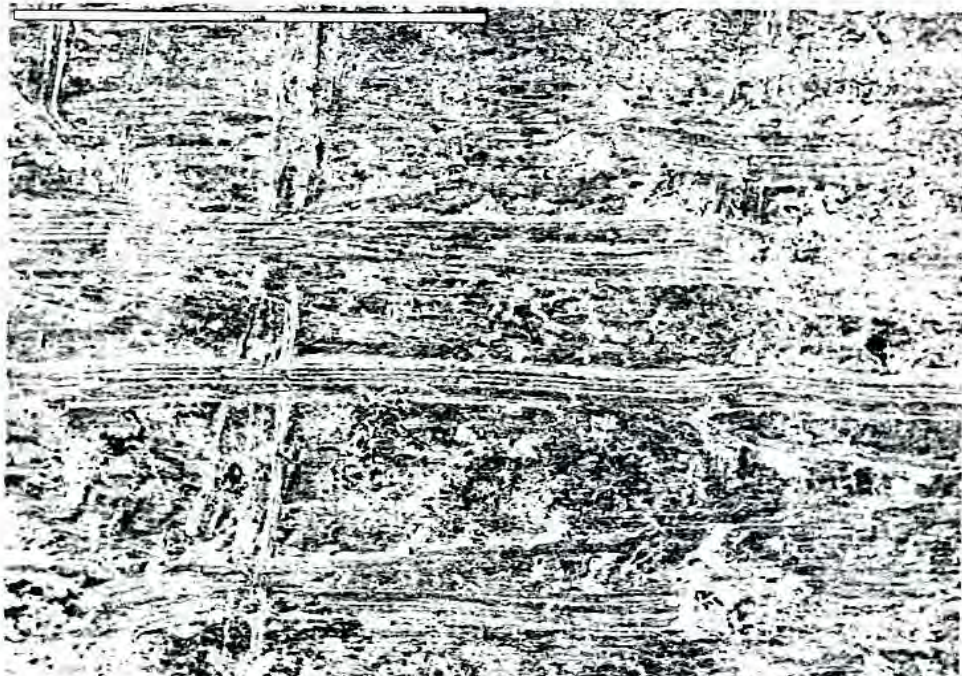
SEM detail of the pattern of mechanical scratches/scores on the tooth No. 6 inactive flank surface.

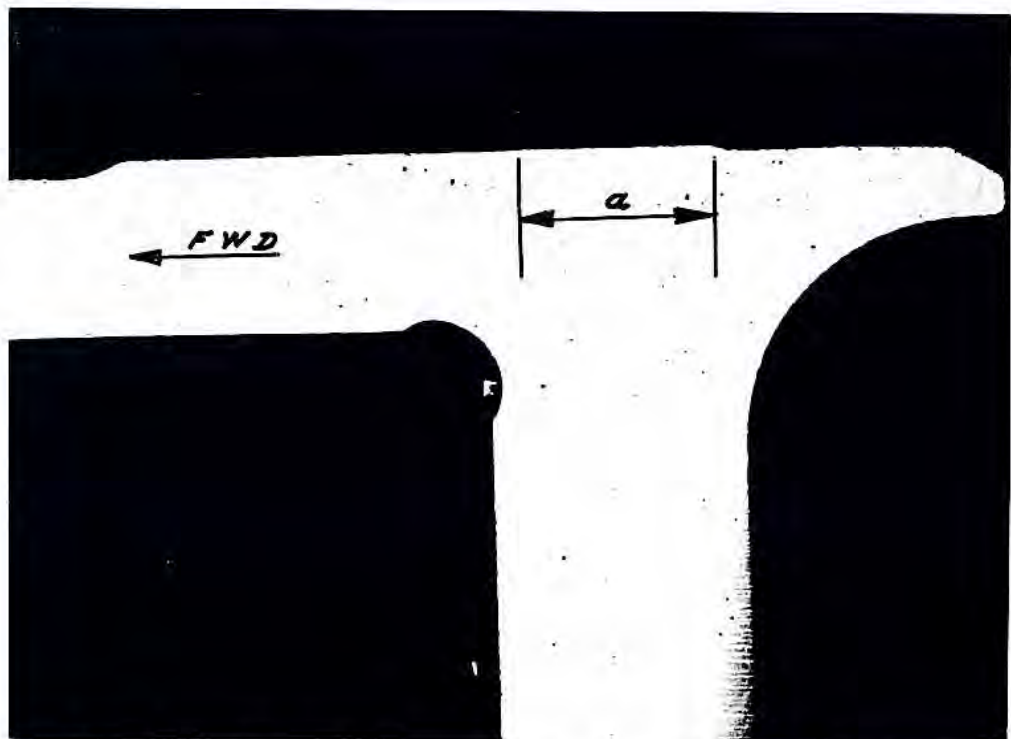
Axial metallographic section through the rear end of the flange unit. The interior cylindric surface is seen at the top of the photo.
Magnification X 12.

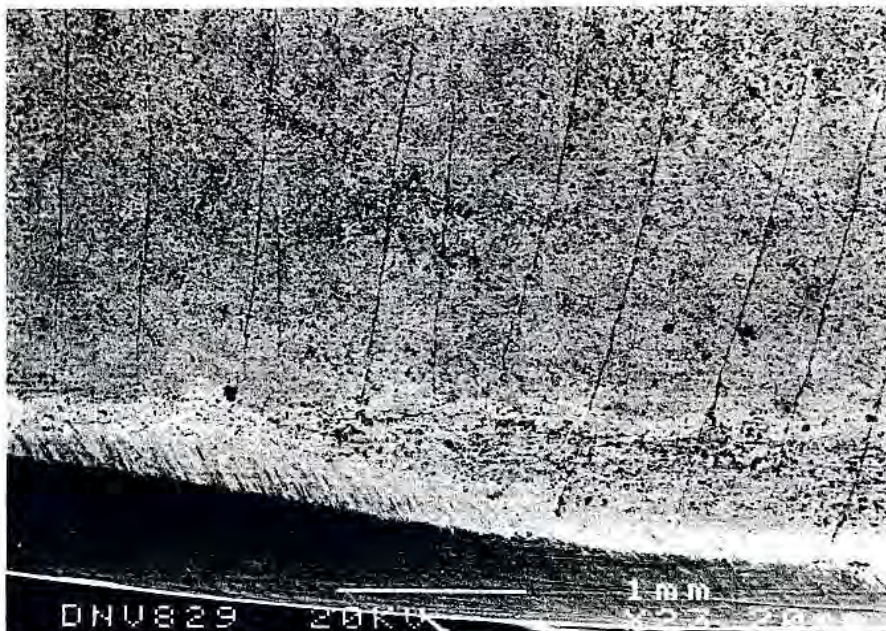
SEM-view of the middle section of the ground front edge location "A" in Fig. 1. Numerous axially directed microcracks are indicated in the surface of the hardmetal coating.
 Magnification X 23.

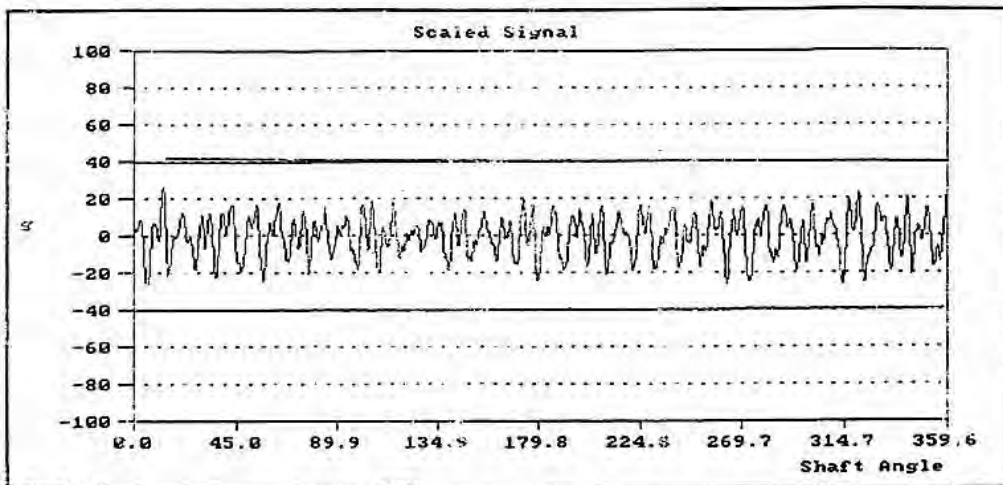
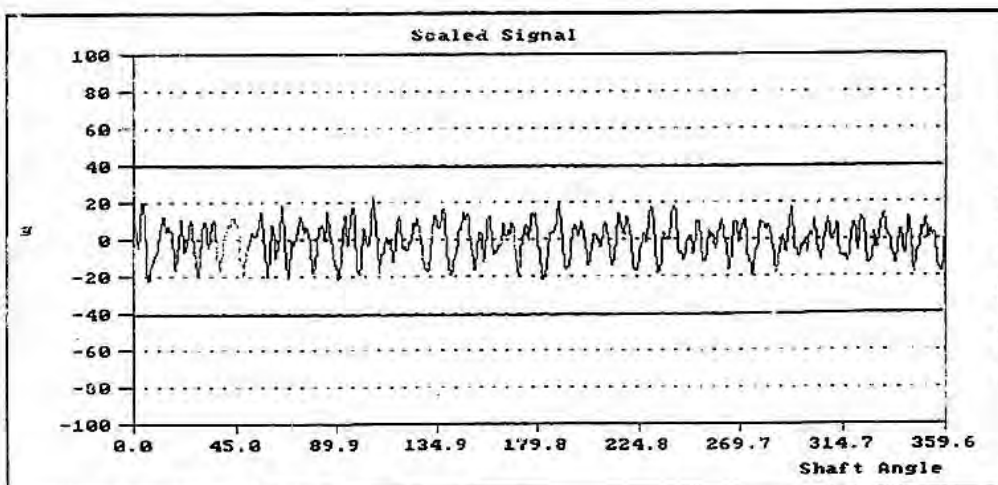
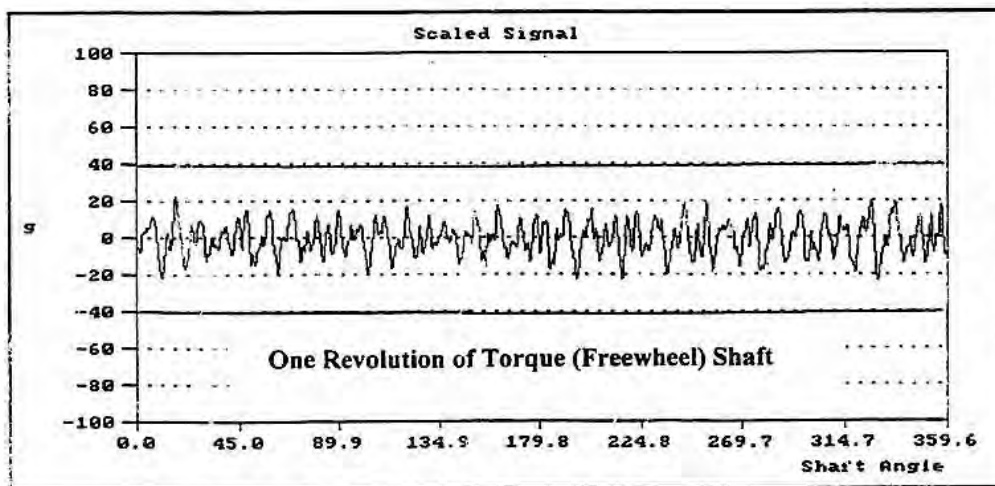
SIGNAL AVERAGES OF RIGHT TORQUE
(FREEWHEEL) SHAFT AFT VIBRATION - DAPU CHANNEL 6
LN-OPG DOWNLOAD 1108B

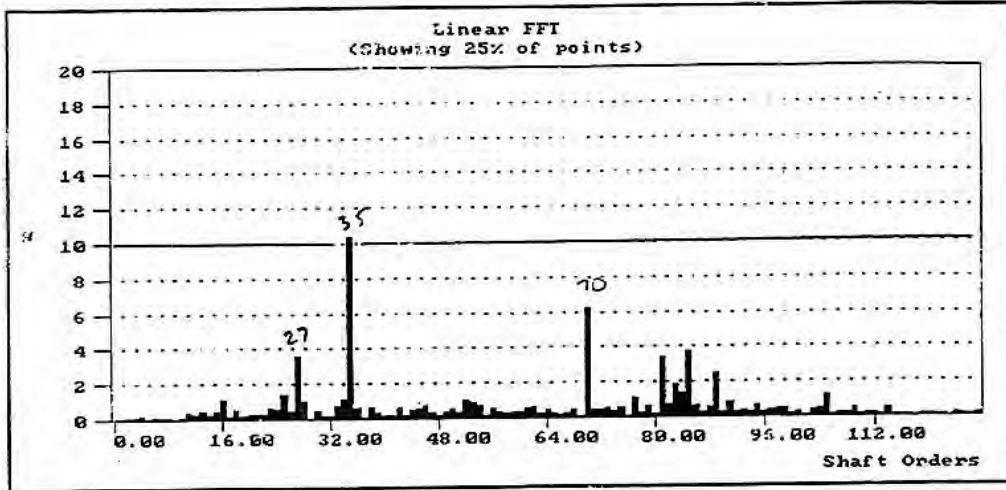
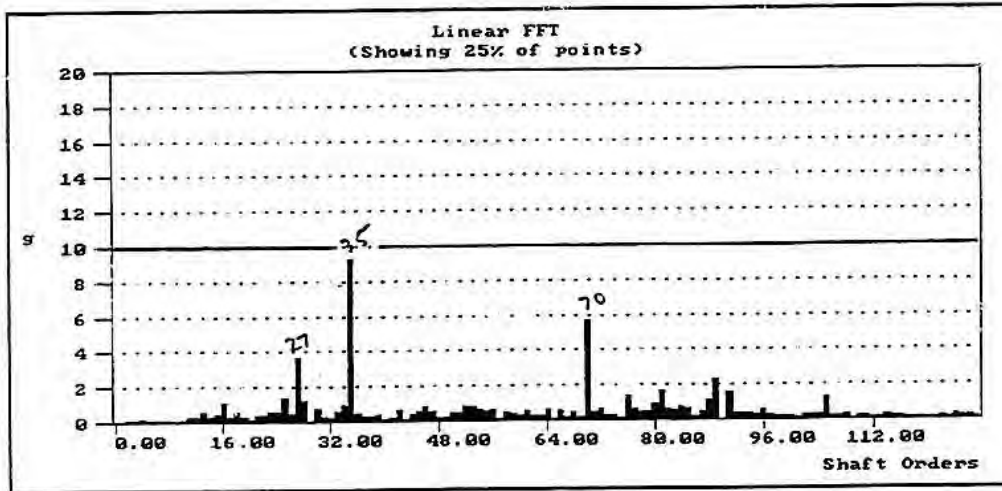
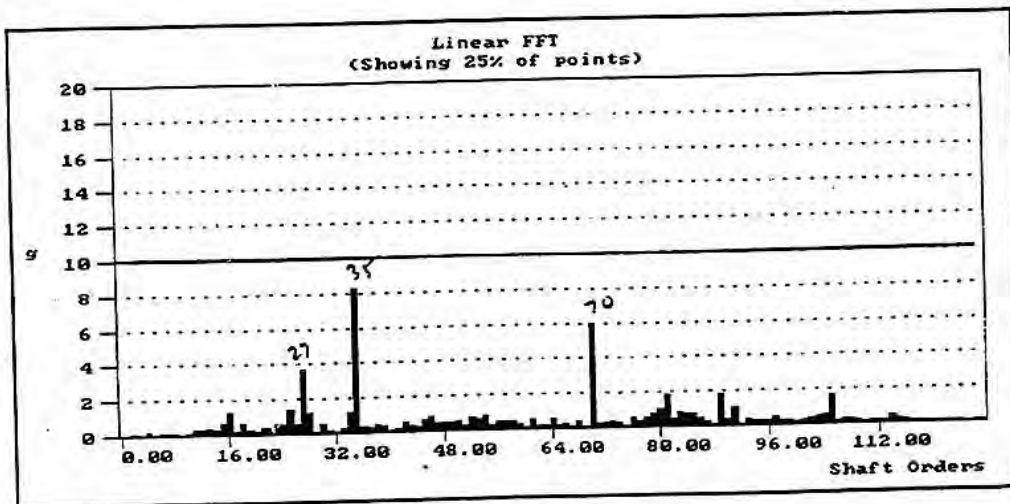
FREQUENCY SPECTRA OF SIGNAL AVERAGES OF RIGHT TORQUE
(FREEWHEEL) SHAFT AFT VIBRATION - DAPU CHANNEL 6
LN-OPG DOWNLOAD 1108B

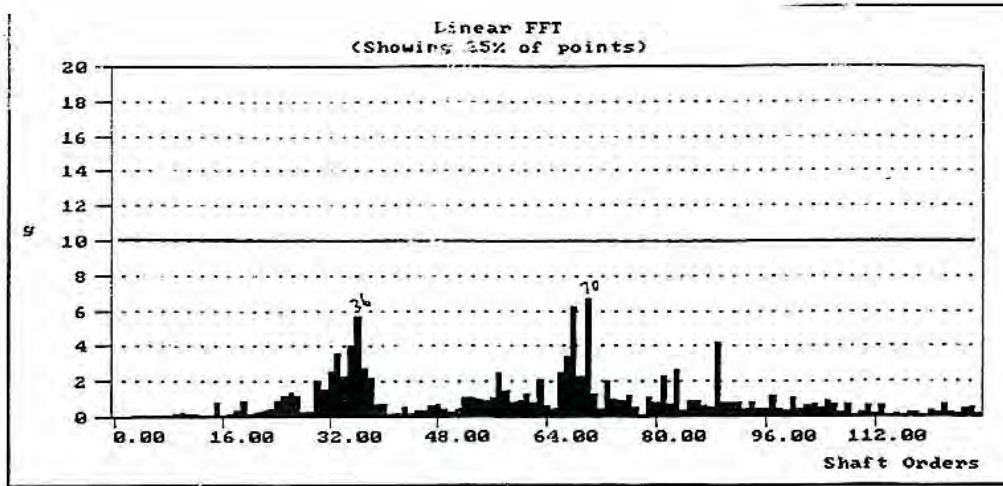
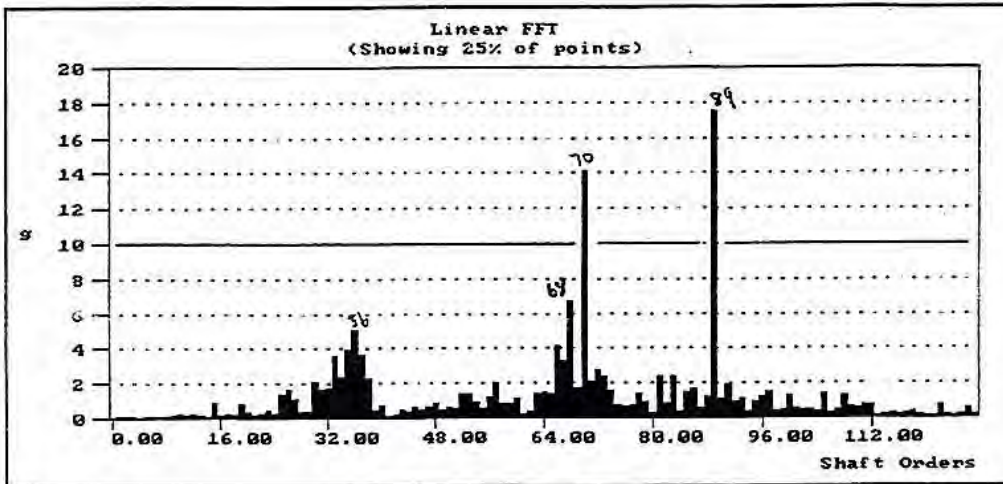
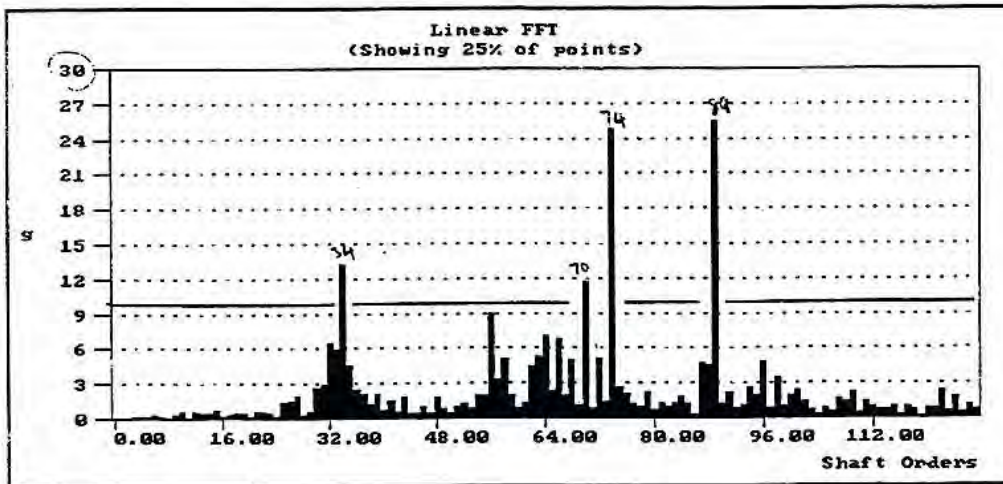
FREQUENCY SPECTRA OF SIGNAL AVERAGES OF RIGHT TORQUE
(FREEWHEEL) SHAFT AFT VIBRATION - DAPU CHANNEL 6
LN-OPG DOWNLOAD 1172A

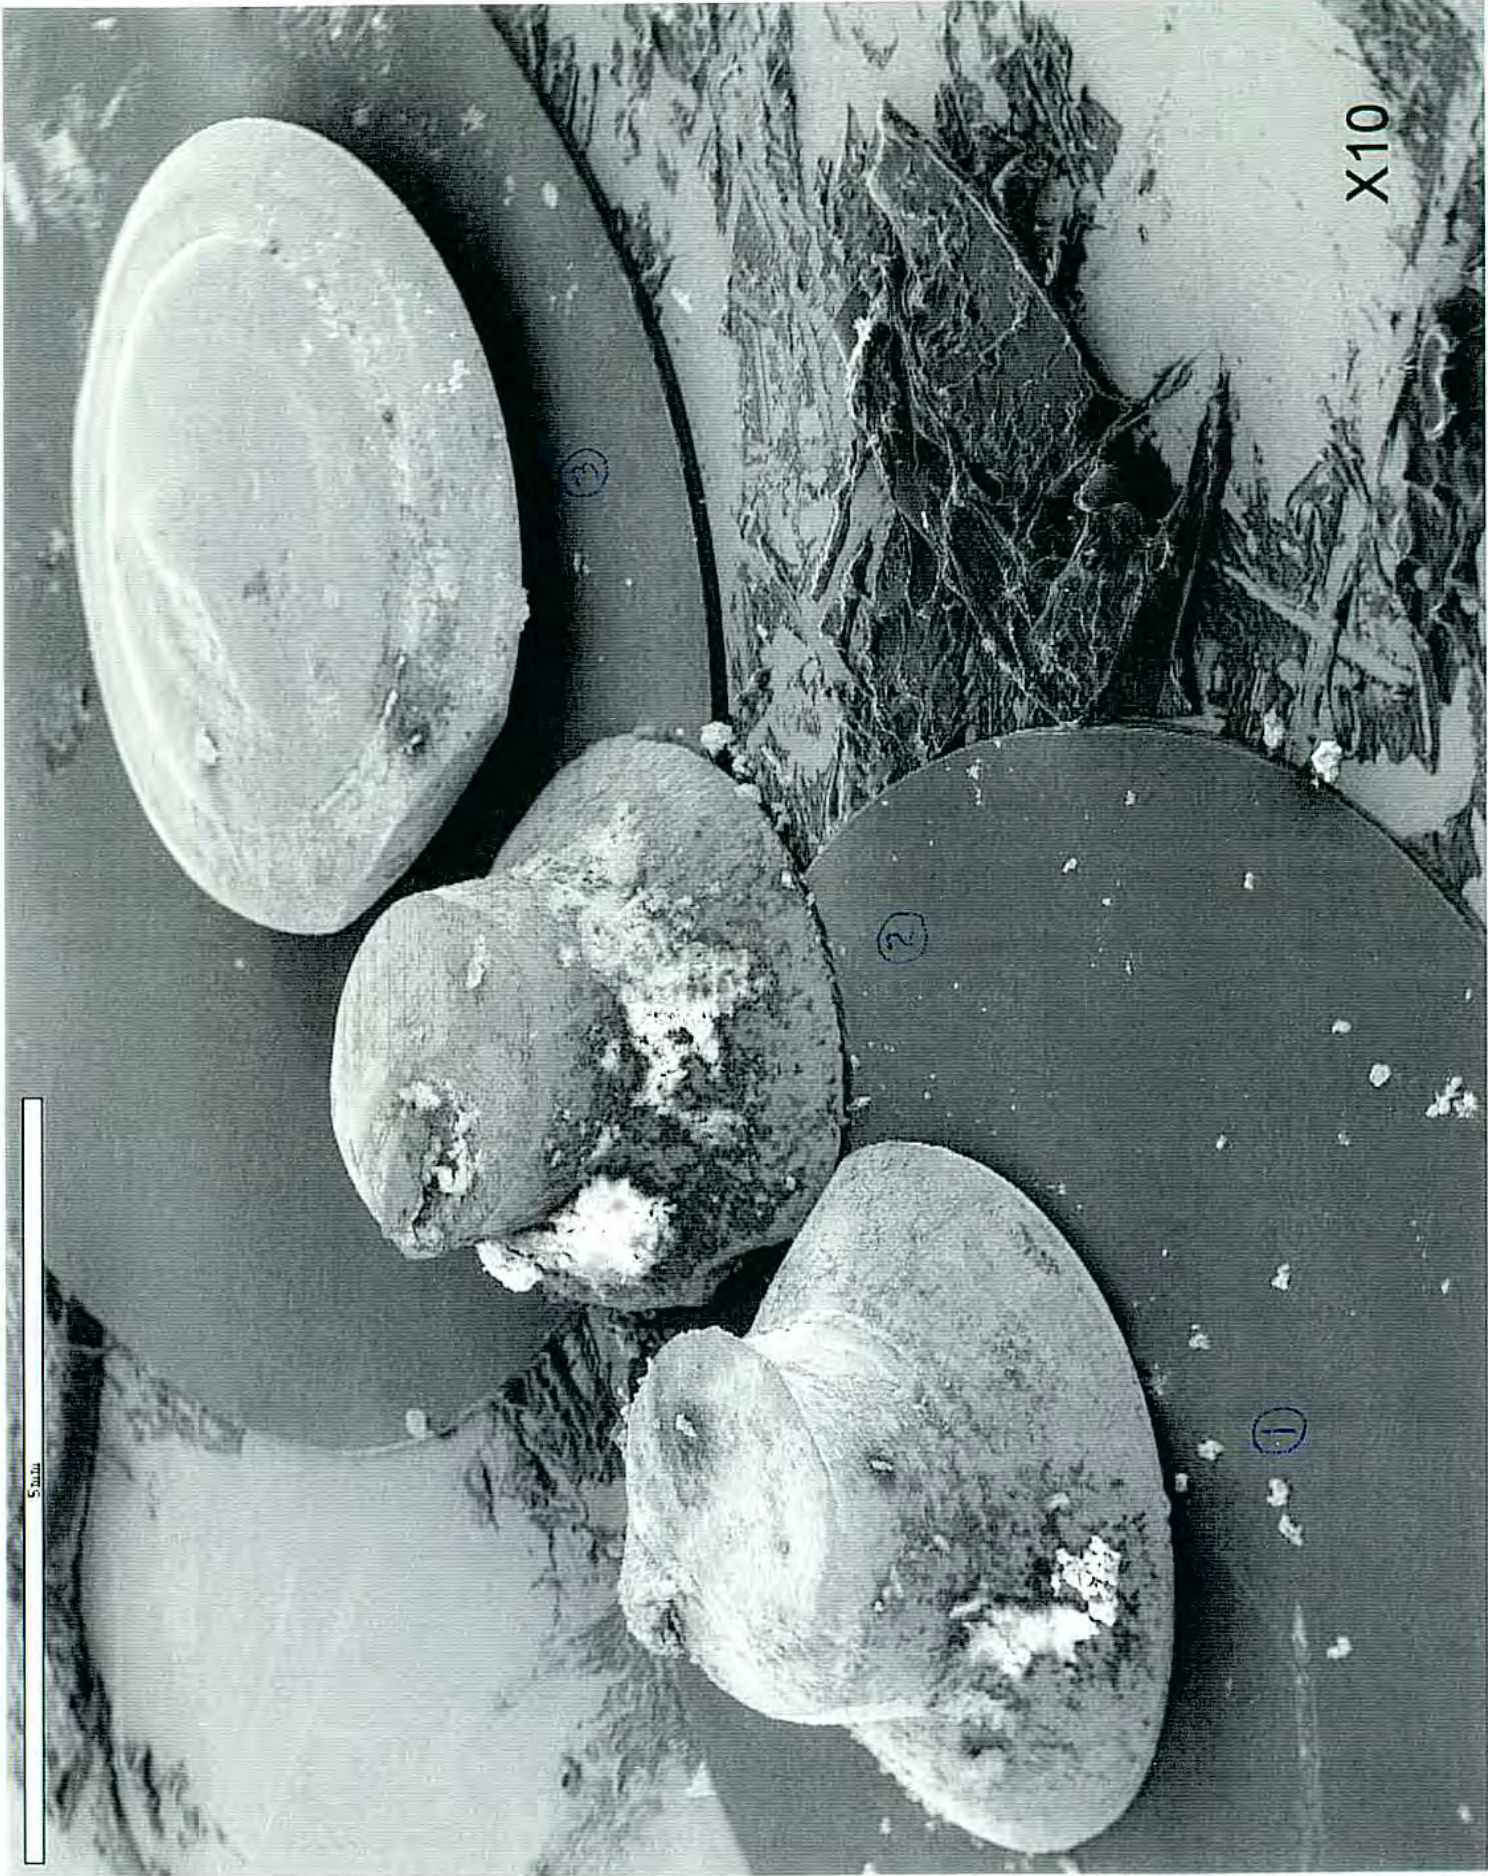
Fig. 75

The investigation revealed that the two rivet heads were hammered so that they became lens-shaped (see fig. 75). A dimple in the flange was investigated, but it was not possible to find traces of fretting in it. However, it was found fretting/fretting corrosion on the mating surfaces on the liaison tube, and considerable amounts of corrosion on the firewall flange and the MGB mounting flange. It was found traces of fretting at the three dowel pins that together with the tie-bolts holds the liaison tube in position. This indicates that there has been relative movement between the liaison tube and the dowel pins/MGB. The investigation of the tie-bolts revealed that they were bent and stretched to a length of 198.4 mm, 202.2 mm and 202.8 mm respectively.
