REPORT

Sjø 2009/01

REPORT ON INVESTIGATION OF MARINE
ACCIDENT MV STAR JAVA - IMO NO 9310513
OCCUPATIONAL ACCIDENT IN SQUAMISH
18.AUGUST 2008

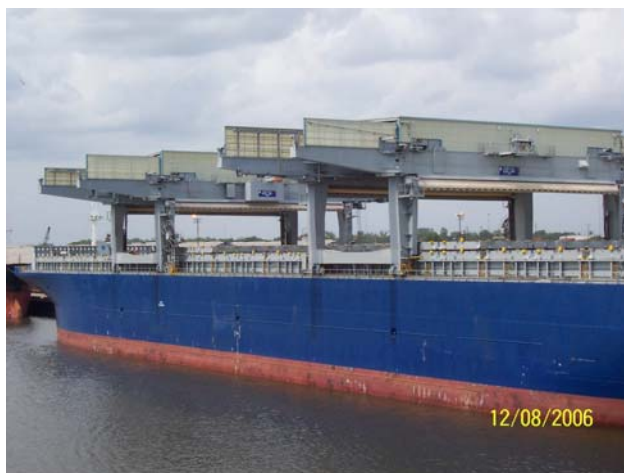
Figure 3: Gantry cranes (the photo is from *Star Isfjord*).

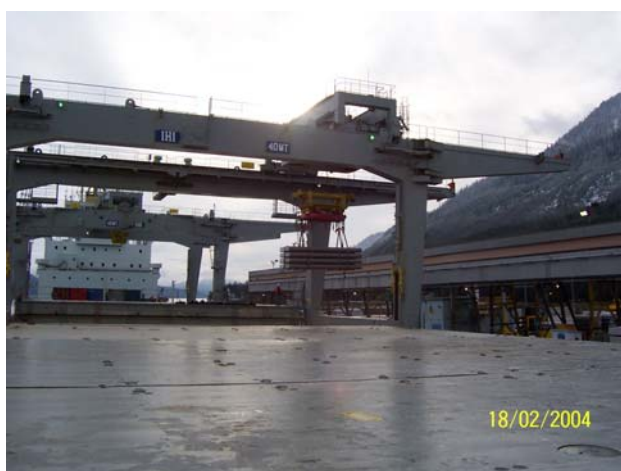
The first generation of gantry cranes were completely open, without any form of roof or walls to protect the cargo against wind and weather. This was the normal crane design until 1985/86. Figure 4 shows the gantry cranes on MV *Star Atlantic*.

Figure 4: Open gantry crane.

All control of the jibs, the trolley and the shifting trolley is done from high up on the girders. Manoeuvre panels for the forward jibs are located on the forward girder out near the end stops, whilst manoeuvre panels for the aft jibs are correspondingly

placed on the aft girder. The jibs are manoeuvred one by one and the manoeuvre positions provide a very good overview.

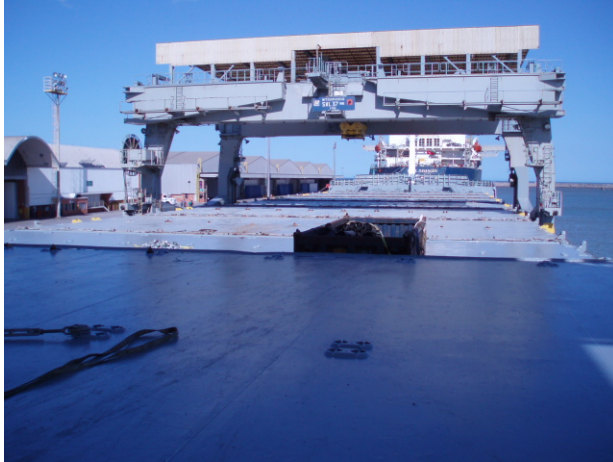
Gradually, the need emerged to protect the cargo against rain during loading and offloading operations. From 1985/86 onwards, most cranes were delivered with roofs. Figure 5 shows the gantry cranes on MV *Star Frazer*.

Figure 5: Partially enclosed gantry crane.
