Investigation of an aviation incident after departure from the Linus offshore oil installation on the Ekofisk field

On 5 June 2023 a Sikorsky S-92A helicopter had an uncommanded engine failure shortly after take-off from the offshore oil installation Linus platform near the Ekofisk field in the North-Atlantic.

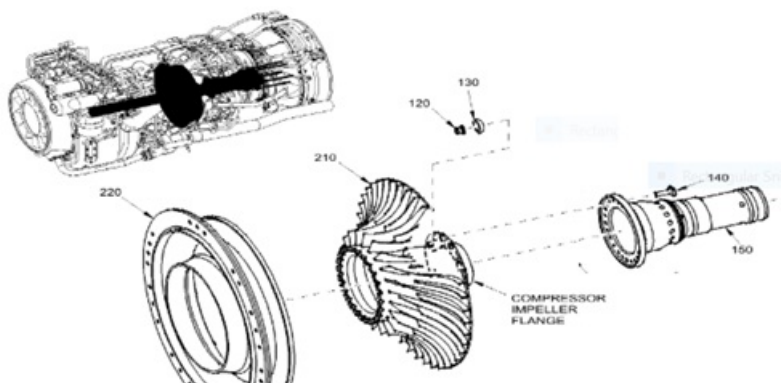
The investigation revealed that twelve bolts joining the compressor and gas generator turbine had ruptured.

Forward flange of the turbine shaft. Photo: NSIA

The NSIA has carried out a metallurgical examination of the twelve bolts. Fatigue has probably started in two of the bolts. The load then increased on the remaining bolts and after a while all twelve bolts ruptured.
