**THE AIRCRAFT ACCIDENT INVESTIGATION BOARD/NORWAY
(AAIB/N)**

REP.: 05/96

**REPORT ON THE AIR ACCIDENT AT
ÅLESUND AIRPORT VIGRA, NORWAY
5 JANUARY 1995 WITH FOKKER F-27 MK 50,
REGISTRATION LN-BBA**

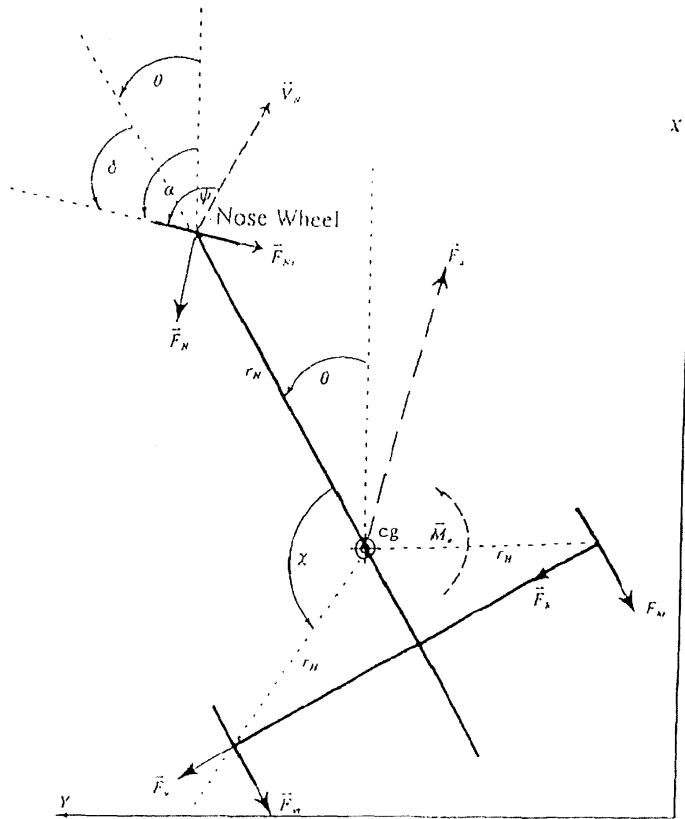
The mathematical model is describing the aircraft movements in the horizontal plane. The principle is that all forces acting in this plane (friction from the wheels and aerodynamic forces) are added up and result in CG velocity. Vertical moments around the CG are also added up and result in changes in aircraft rotation. Figure 1 is showing all forces and turning moments acting in this plane.

Forces acting upon main wheels, nose wheel and Center of Gravity (CG).
