Appendix D:

**Stability calculations carried
out by the NSIA**

APPENDIX D - STABILITY CALCULATIONS CARRIED OUT BY THE NSIA

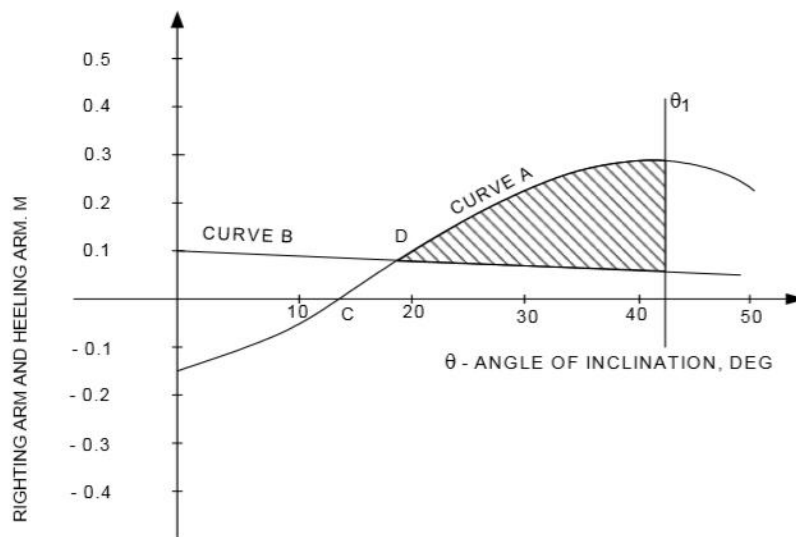
402 The angle of heel (Point C in Figure 3) shall not exceed 15° in the final condition of equilibrium. When the damaged vessel is subject to a wind force calculated as outlined in C301, assuming a nominal wind speed of 40 knots, the following criteria shall be met: The available dynamic stability beyond point D in Figure 3 up to the angle θ_1 , i.e. the shaded area shall not be less than 0.025 mrad. The angle θ_1 shall be taken as 45° or the angle at which

progressive flooding (submersion of unprotected opening) would occur, whichever is less.

Figure 3 Stability criteria for flooded condition
