REPORT

Date: 14.12.2006
SL Report: 31/2006

- Type and reg.: Cessna 208B, LN-PBF
- Year of manufacture: 1996
- Engine: PT6A-114A

Serious incident, loss of altitude in icing conditions

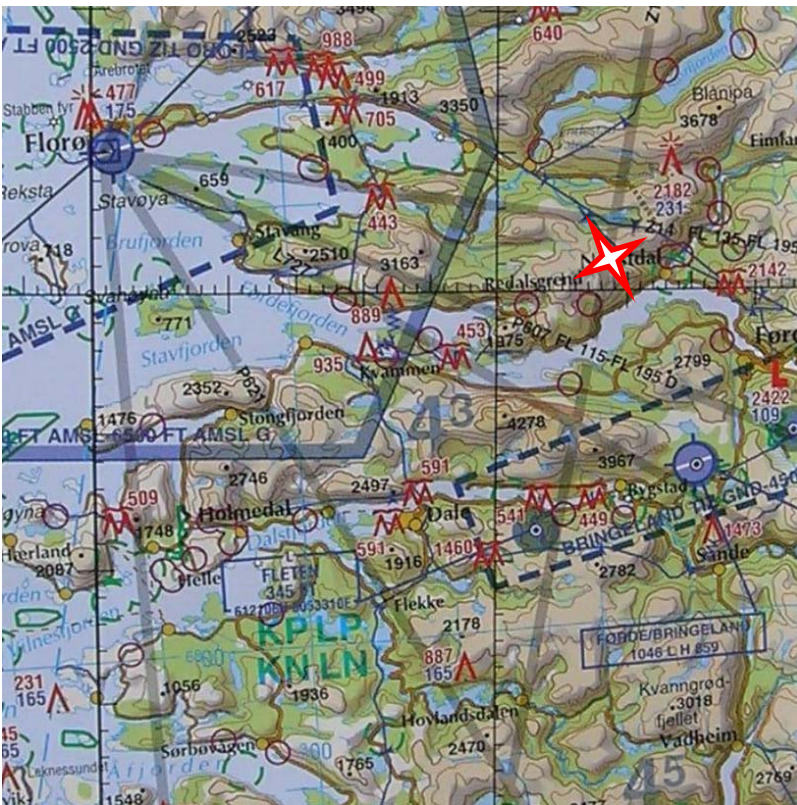
Fig. 1 Map of the area where the icing problems arose

At approx. 0745, when they were approaching the mountains east of Florø, 25 NM south of the SOVIG reporting point, icing quickly became considerably worse. The crew observed that ice was building up in the underside of the wings, and that the "boots" were not removing this. Flight speed was decreasing, and as they entered mountain waves and lost altitude it became impossible to return to FL 110.
