## Investigation of aircraft accident at Sognesand, Sandnes Municipality, Rogaland County, Norway

On 16 November 2020 LN-OAX, an Airbus helicopters AS 350 B3, lost control during delivery of concret to a powermast fundament.

Latest update: 21.02.2024

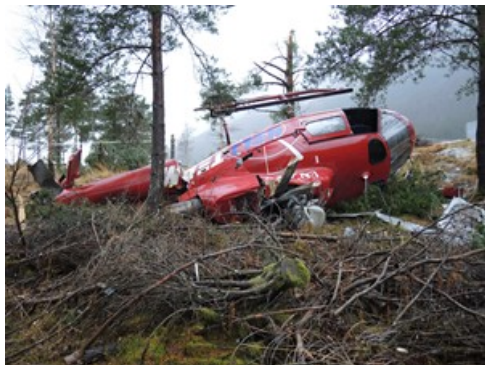
Photo: NSIA

The aircraft was performing external load flights with delivering of concrete to a powerline fundament. During delivery of concrete to powerline mast number 49, the pilot experienced severe vertically vibrations. The pilot took immediate action, released the external load and was capable to manoeuvre the helicopter away from the construction area. During this operation the helicopter lost altitude and hit some threes. The helicopter stopped laying on the right-hand side about 33 meters from the construction area. No persons were seriously injured.

After initial inspection at the accident site the helicopter has been transported to the Norwegian Safety Investigation Authority's facilities in Lillestrøm, Norway for further examinations.

The reason for the oscillations is likely that the helicopter came up in a situation where the

Rotorcraft Pilot Coupling occurred. In 2023, Airbus Helicopters published two safety informations describing the phenomenon Pilot Induced Oscillation. (SIN 3899-S-67 and SIN 3890-S-00).
